Apartment Complex Fire, 66 Units Destroyed Seattle, Washington

Apartment Complex Fire, 66 Units Destroyed Seattle, Washington (September 21, 1991)

Investigated by: Philip Schaenman

**This is Report 059 of the Major Fires Investigation Project conducted
by TriData Corporation under contract EMW-90-C-3338 to the United
States Fire Administration, Federal Emergency Management Agency.**

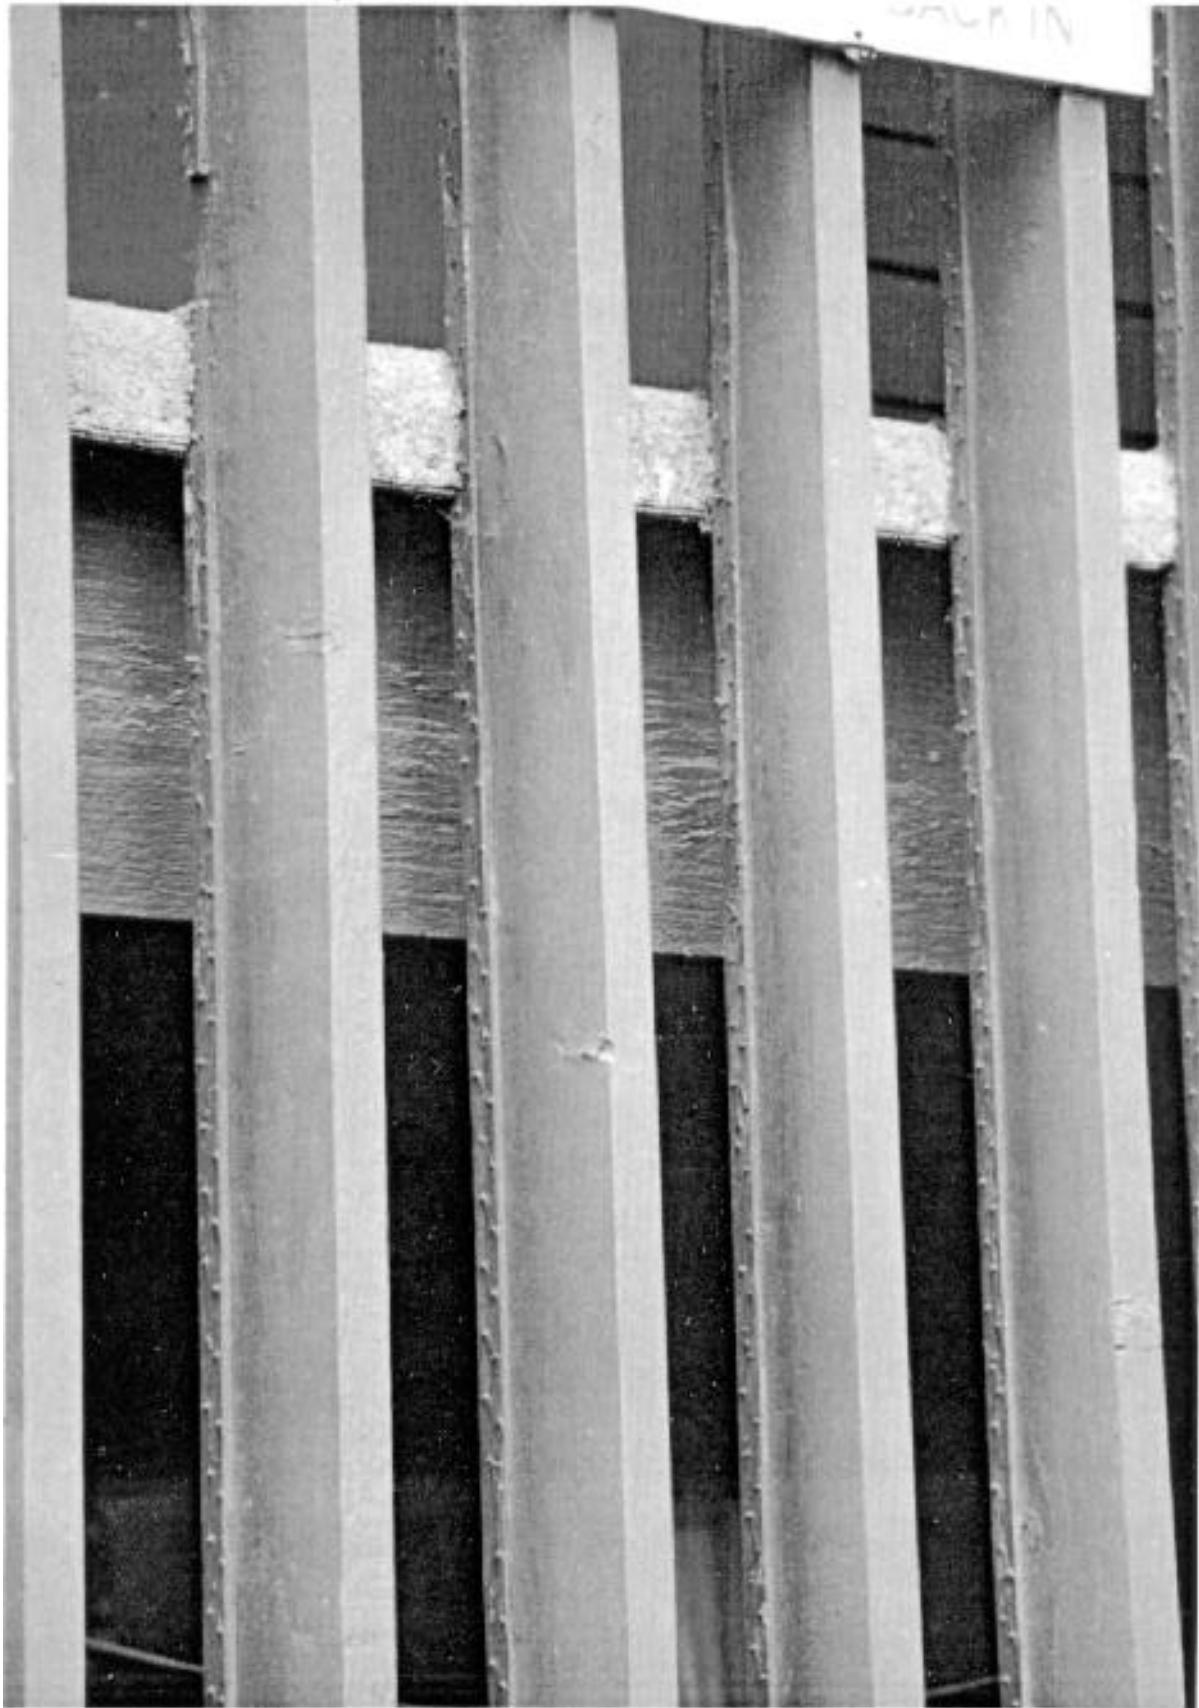
Close-up of the decorative cedar screen on the fronts of the buildings, which served a security purpose as well. Fire could race unimpeded up the wood 2 x 6's. The photograph shows the screen as it passes the outdoor carpeted floor of the walkway above.

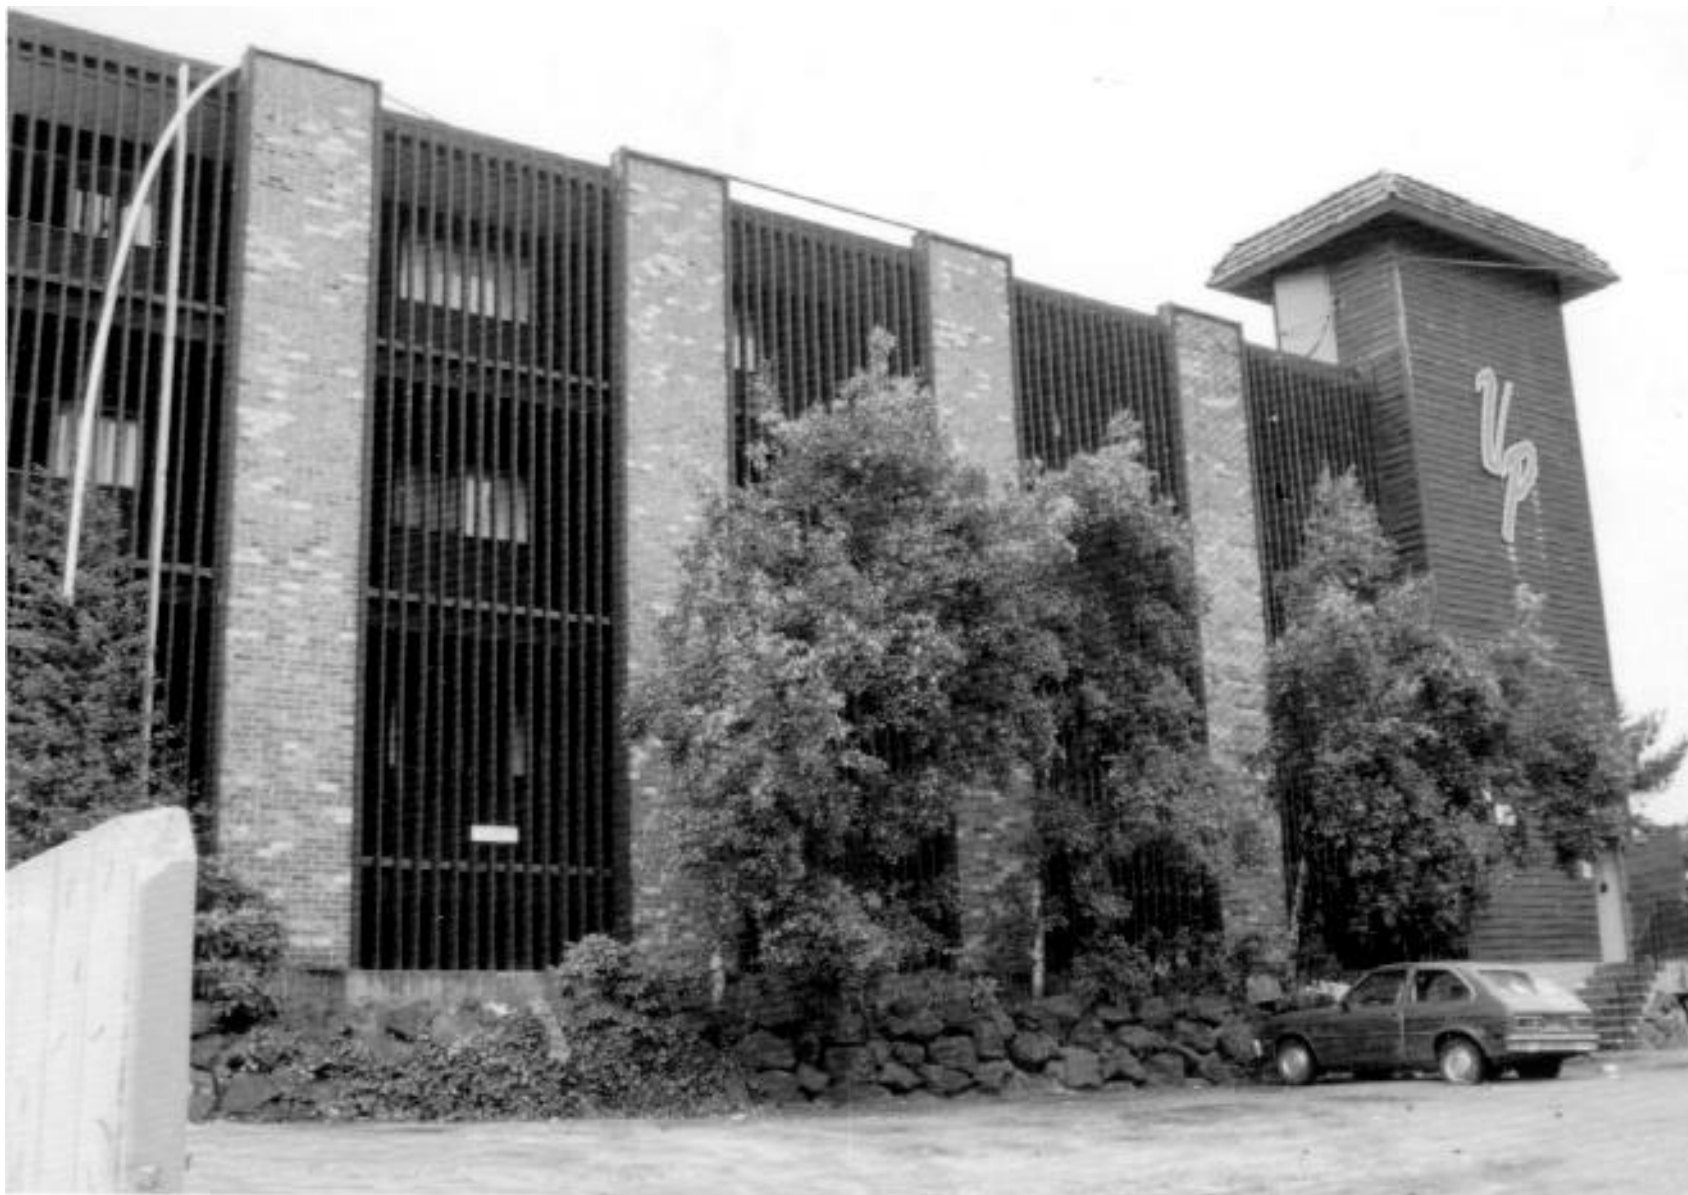
The exterior facades of the walkways on the fronts of the buildings were 4-story high decorative lattices comprised of 2" x 6" vertical cedar boards approximately on 9-inch centers. (The space between the vertical cedar boards was about seven inches.) The lattices had 10-foot widths separated by 5-foot brick fascia. These lattices were both for aesthetics and security. The wood had been covered with oil-based stain. The wood had dried out in the approximately 30 days without rain prior to the fire.

Typical exterior construction, brick facia with 2" x 6" slated security fencing.

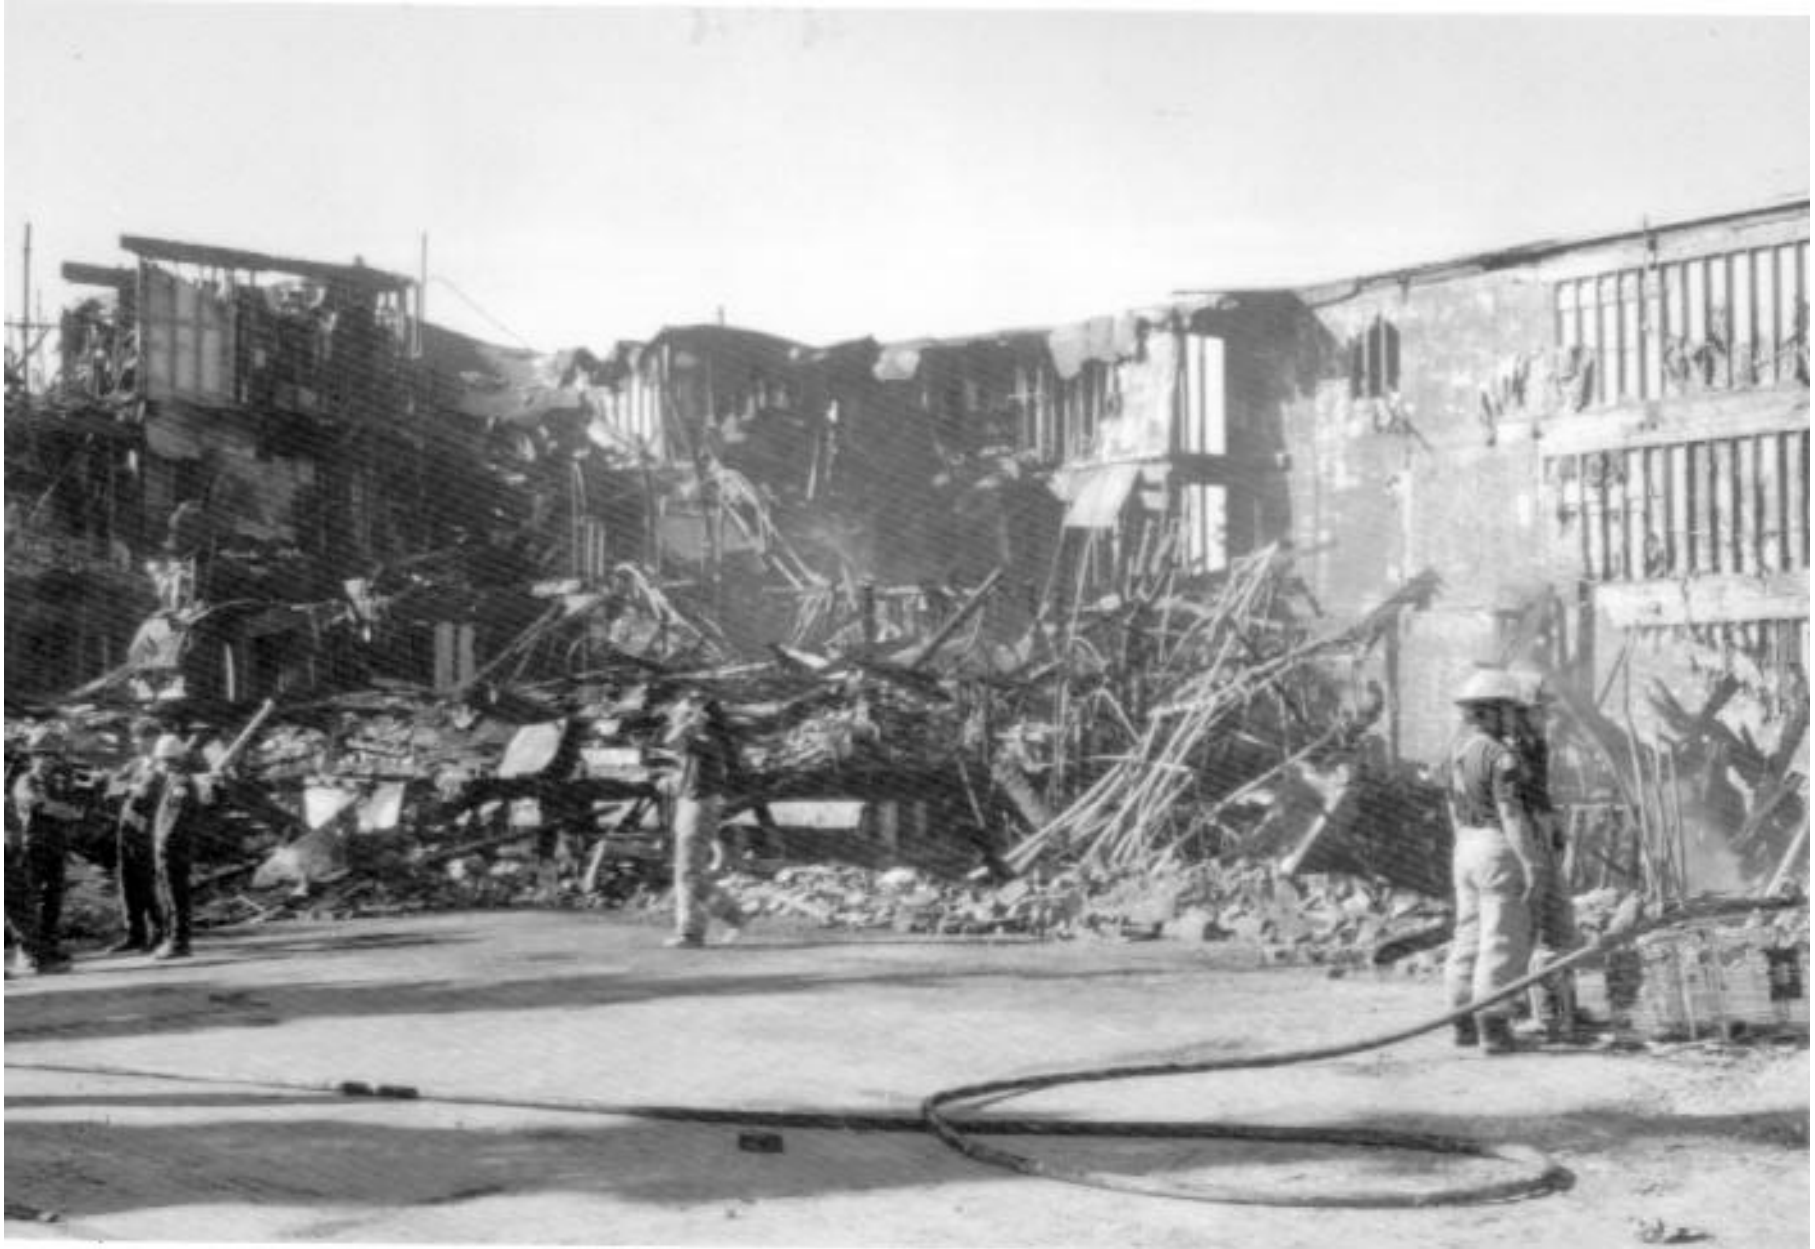
View from the southeast looking northwest.

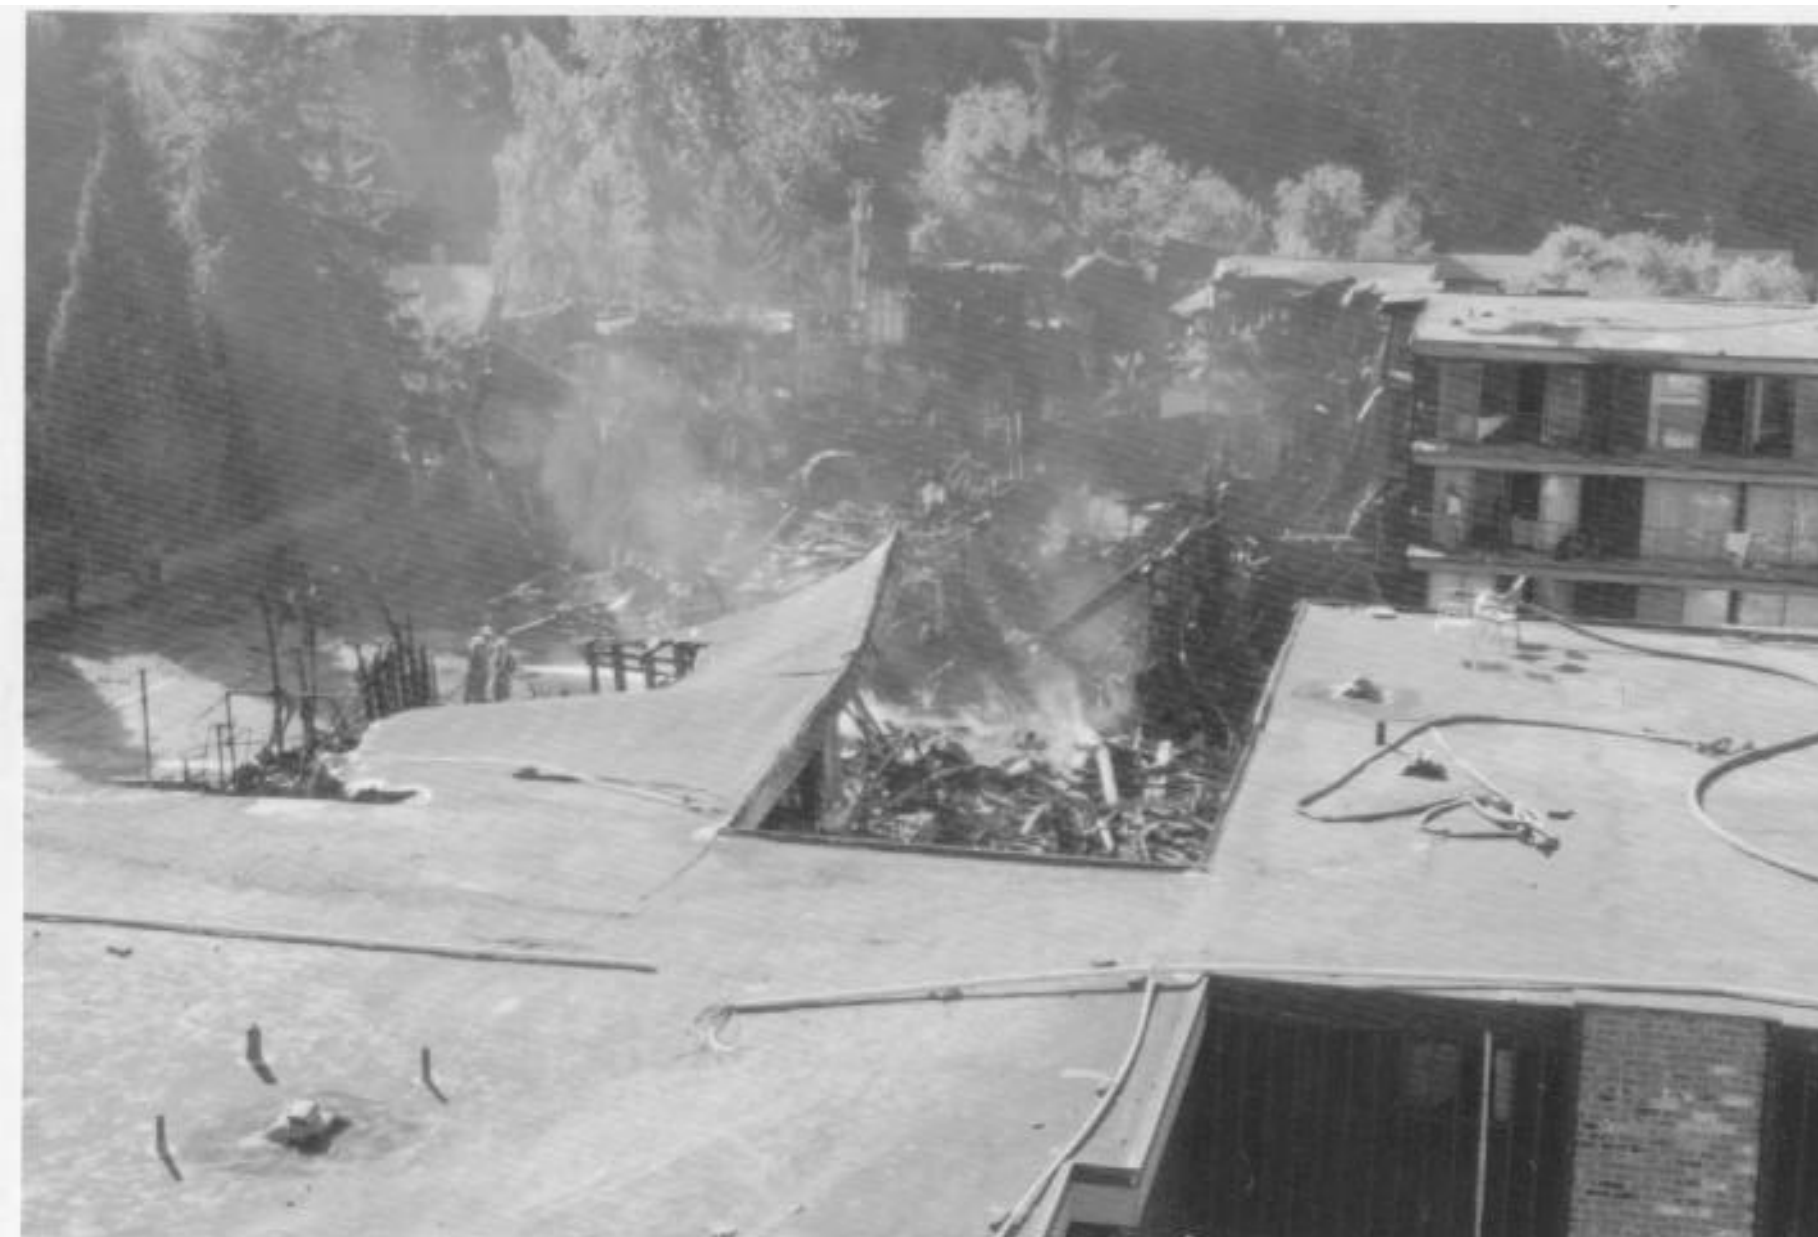
The South wing of the apartment complex had been completely destroyed by fire. The general area of most severe damage was slightly west of the center of the wing. Most or all of the structural members of apartments 116, 115, 114, 113, and 112 were totally consumed.

Overview of south wing looking west.

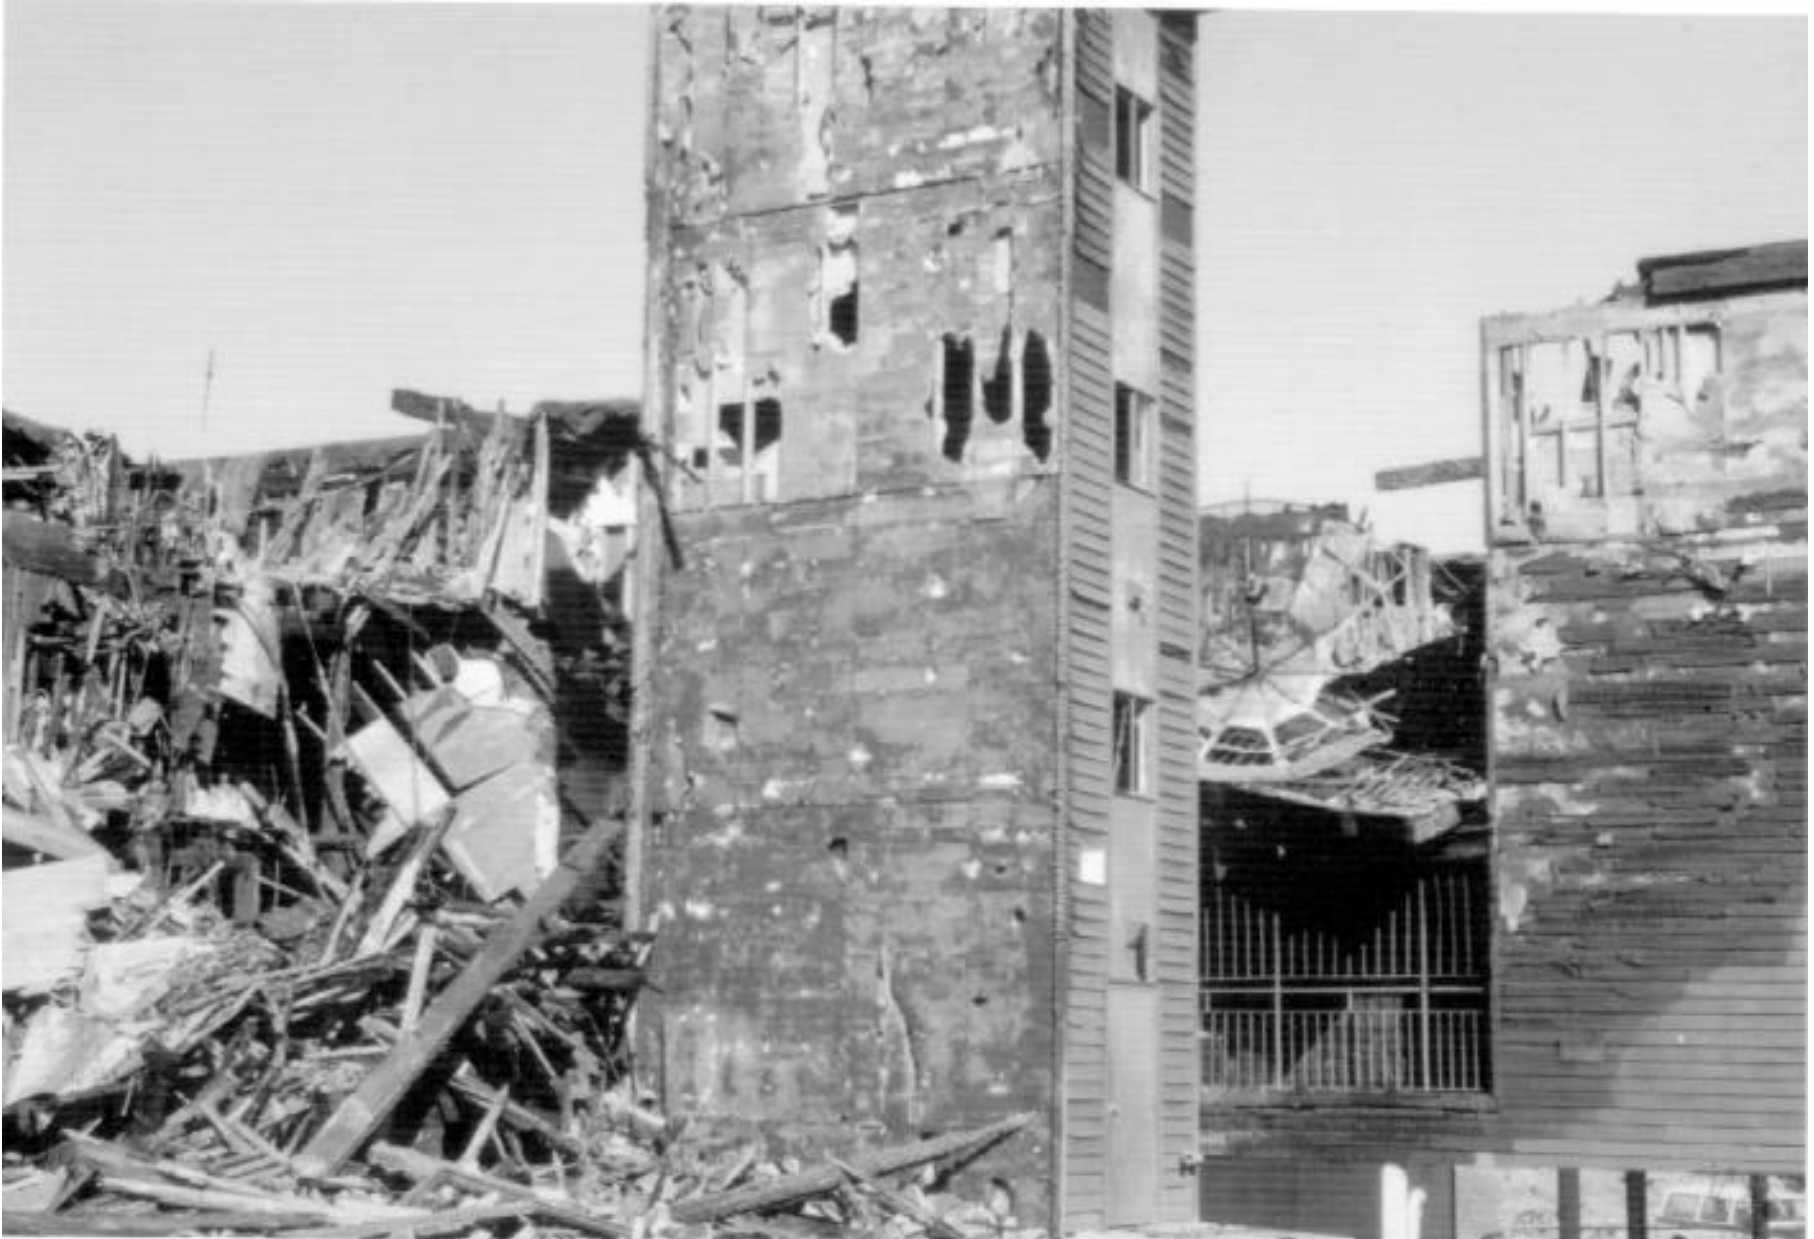
Easterly view showing stairwell enclosure that remained at the east end of the destroyed complex.

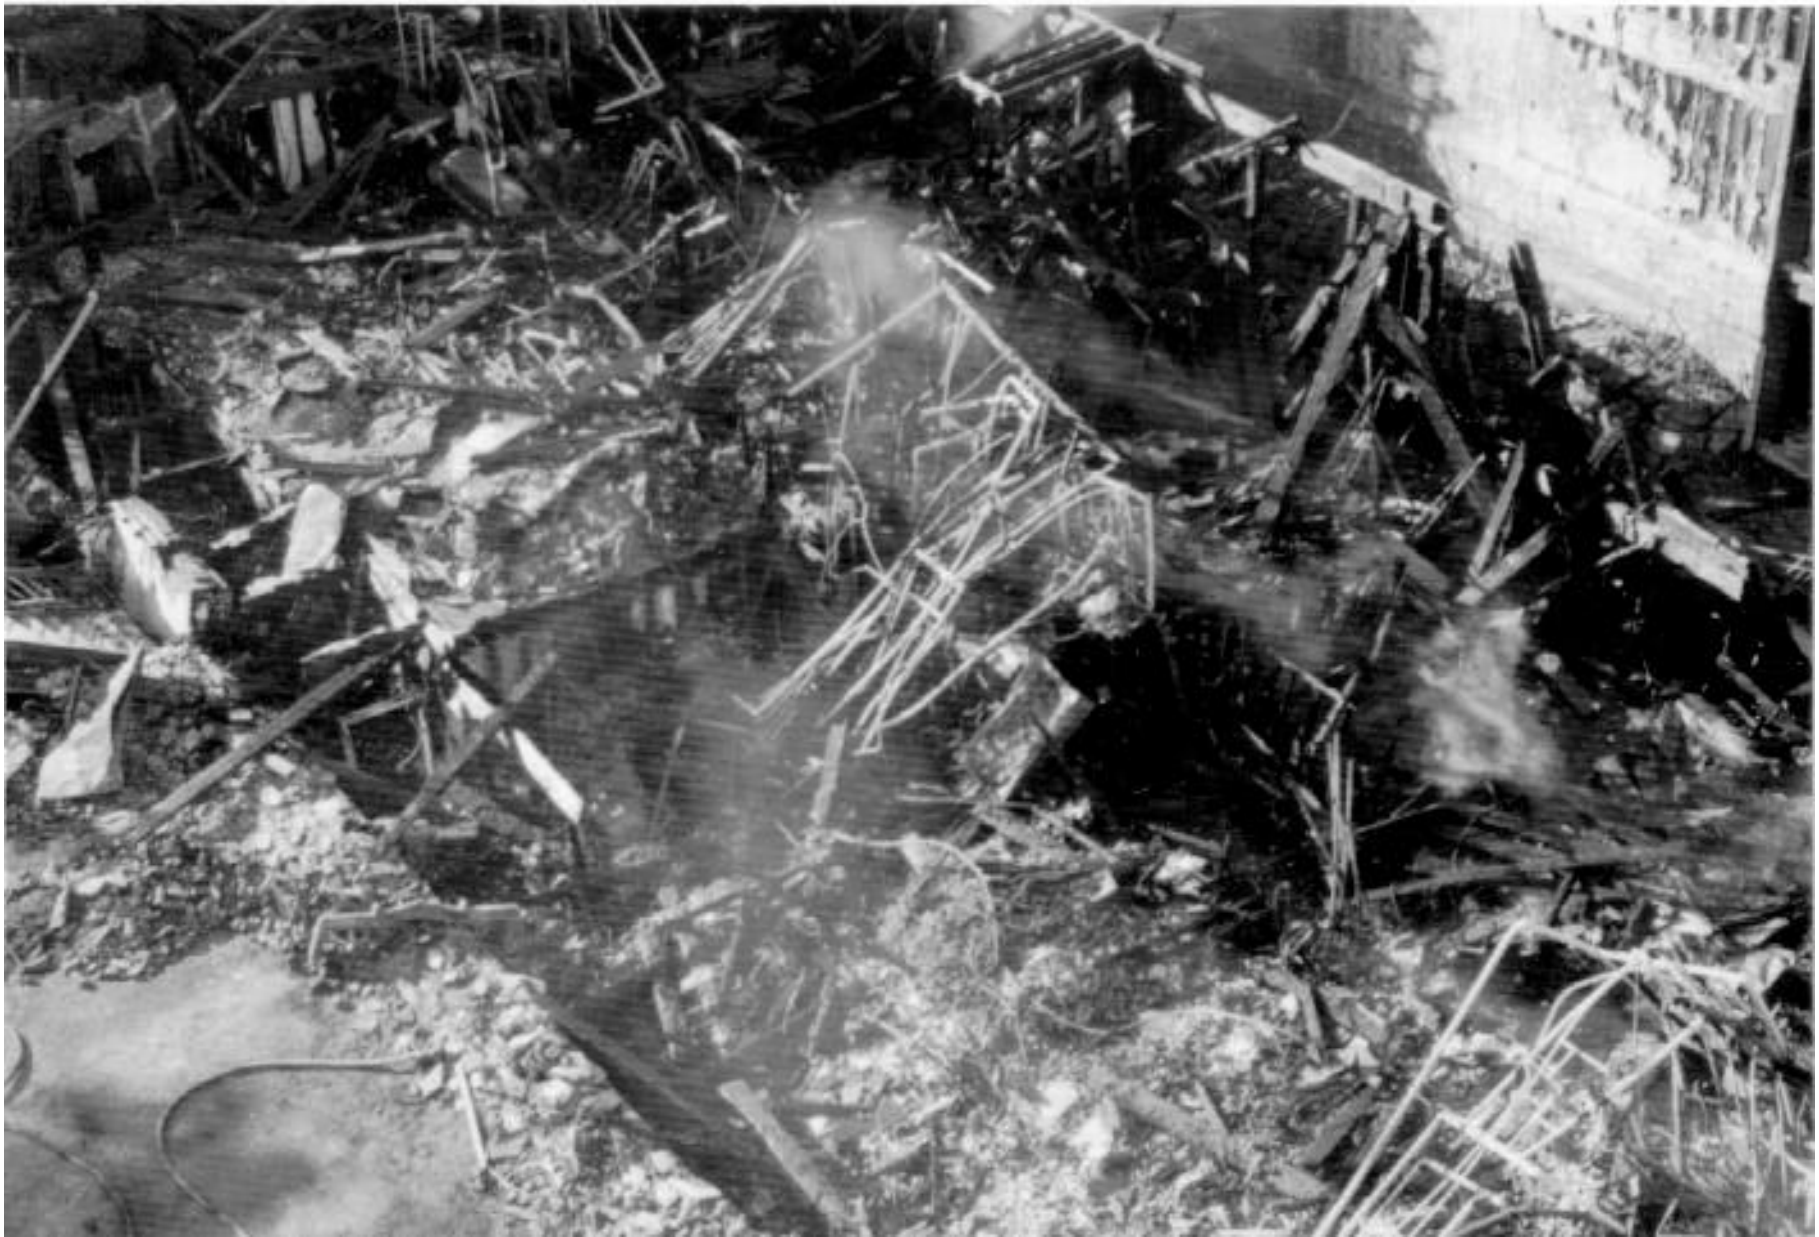
Based on the facts and observations noted in the body of this report, it is the opinion of the investigators that this is an accidental fire. It originated in apartment #115 in the east bedroom. The fire was a result of a tenants attempt to light the room with use of a candle due to disconnected electrical service to the apt. Paper was placed on dwindling candle in an attempt to provide a better light. This flame exceeded it's intended purpose and an attempt was made to blow it out. This attempt resulted in blowing burning paper debris onto the floor and behind the dresser igniting available combustible items.

Aerial view of area of origin (Unit 115).

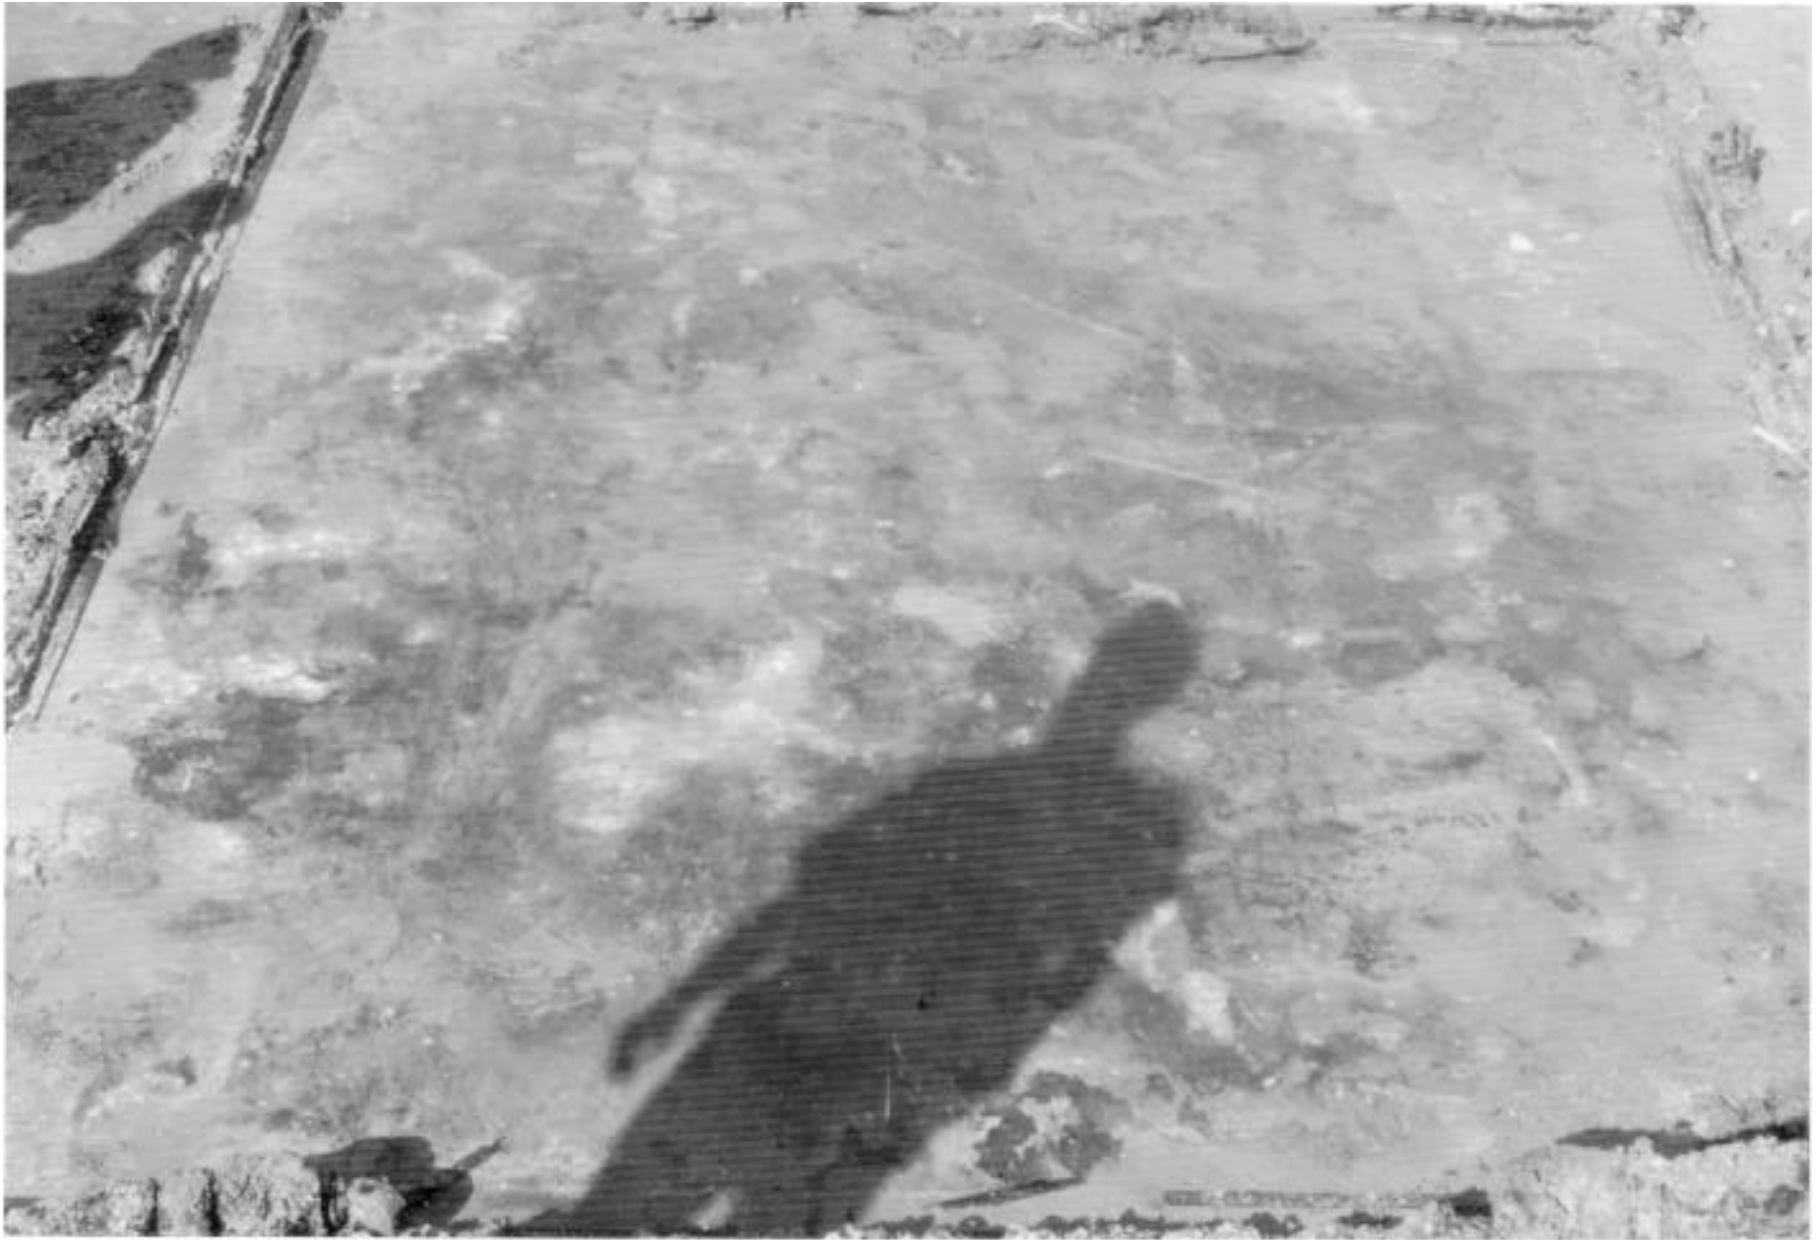
Excavation of the debris of apartment 115 failed to produce any electrical or gas appliances in the area of the master bedroom. A dinner plate was found in the area of the dresser where the occupant indicated the candle had been placed.

Slab of room of origin, southeast bedroom.

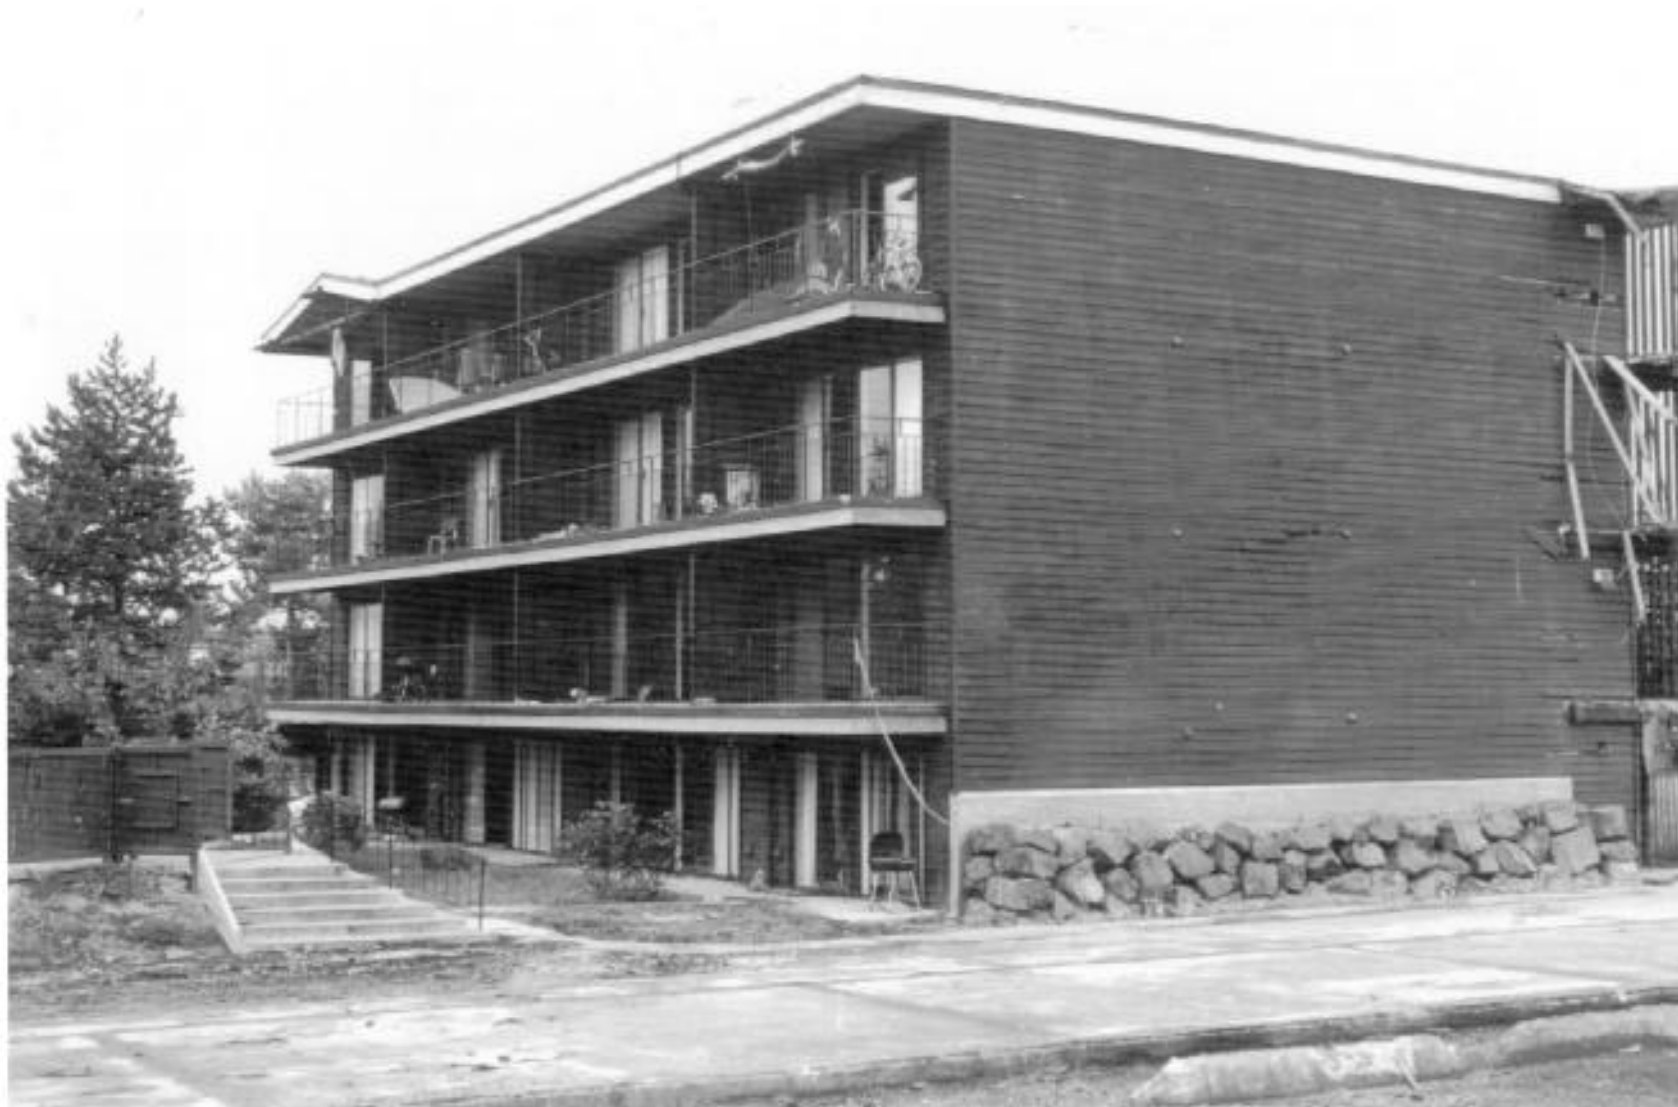
(Photo provided by Philip Schaenman)
South and west sides of Building E. Note that only a small amount
of damage was done to this building, at its southeast corner.

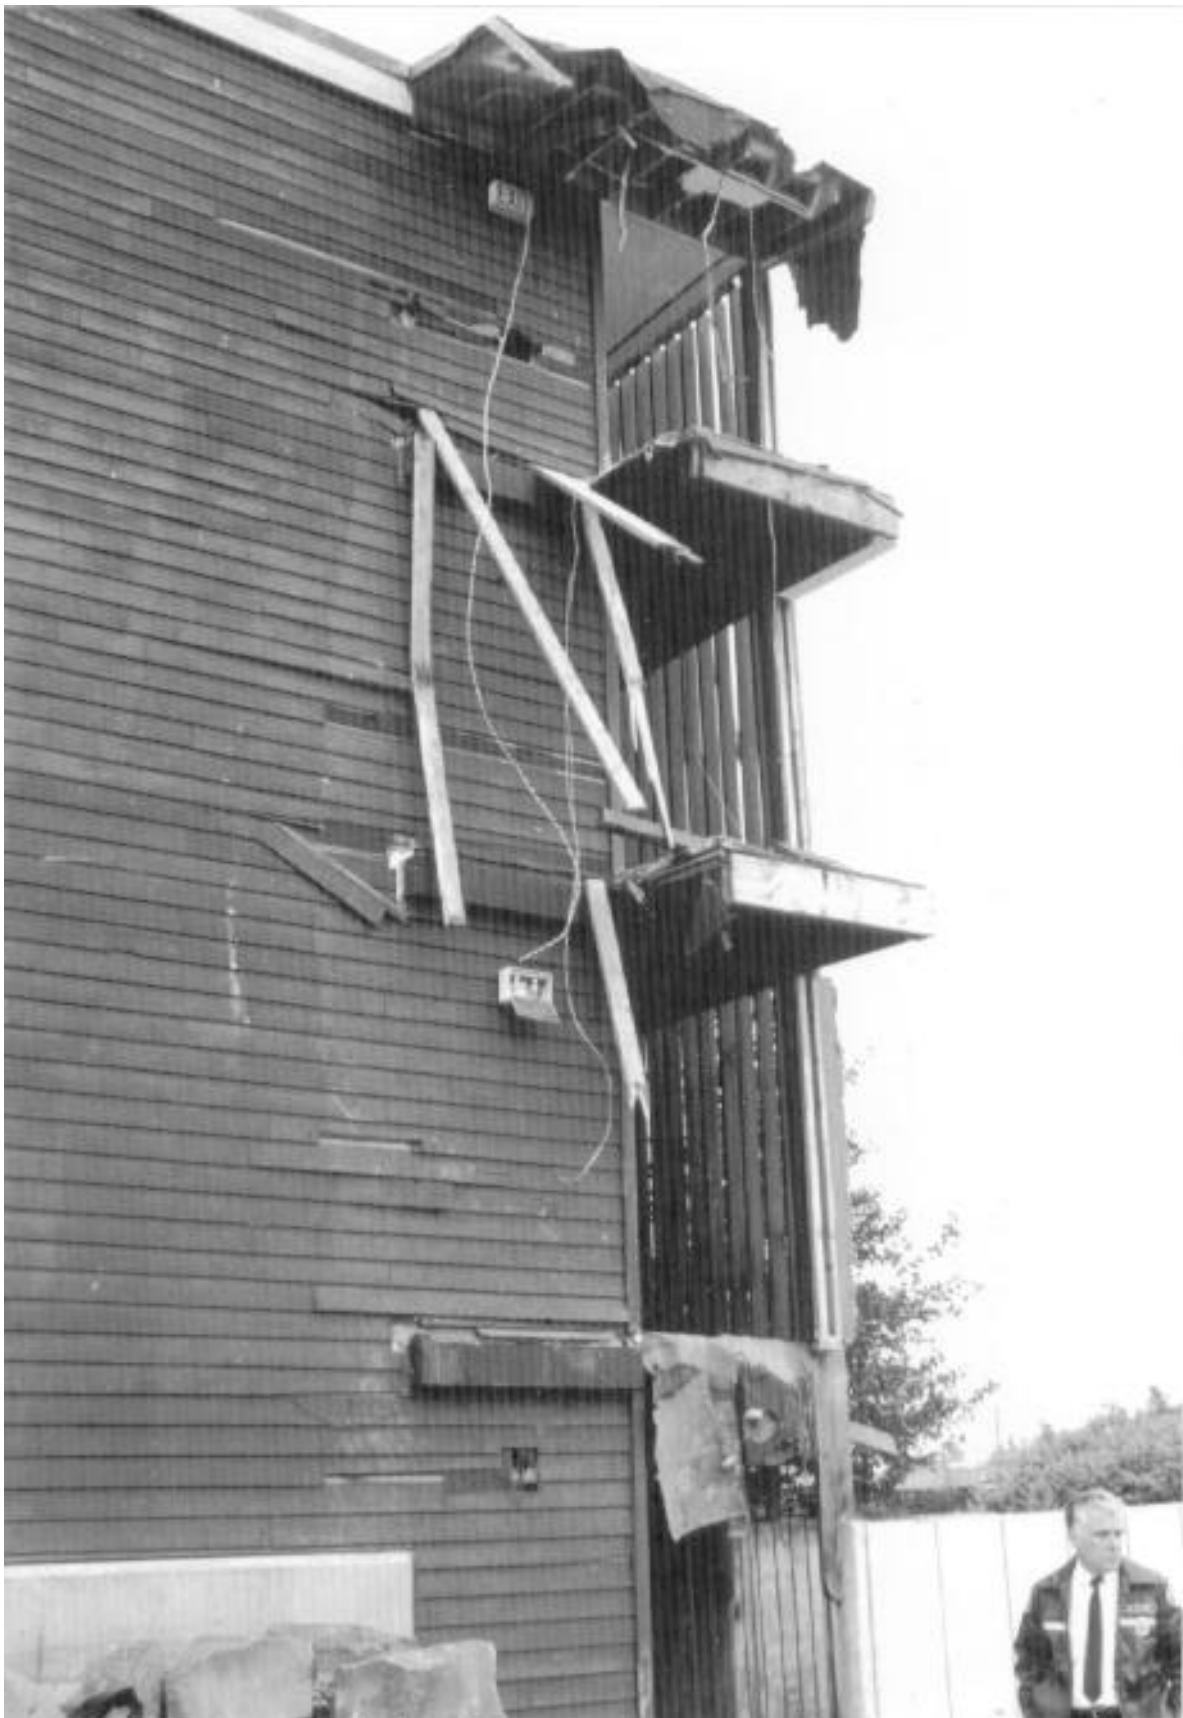
Closer view of damage of southeast corner of Building E. The wooden platforms jutting out on the right were part of the walkway attached to Building D, which was demolished.

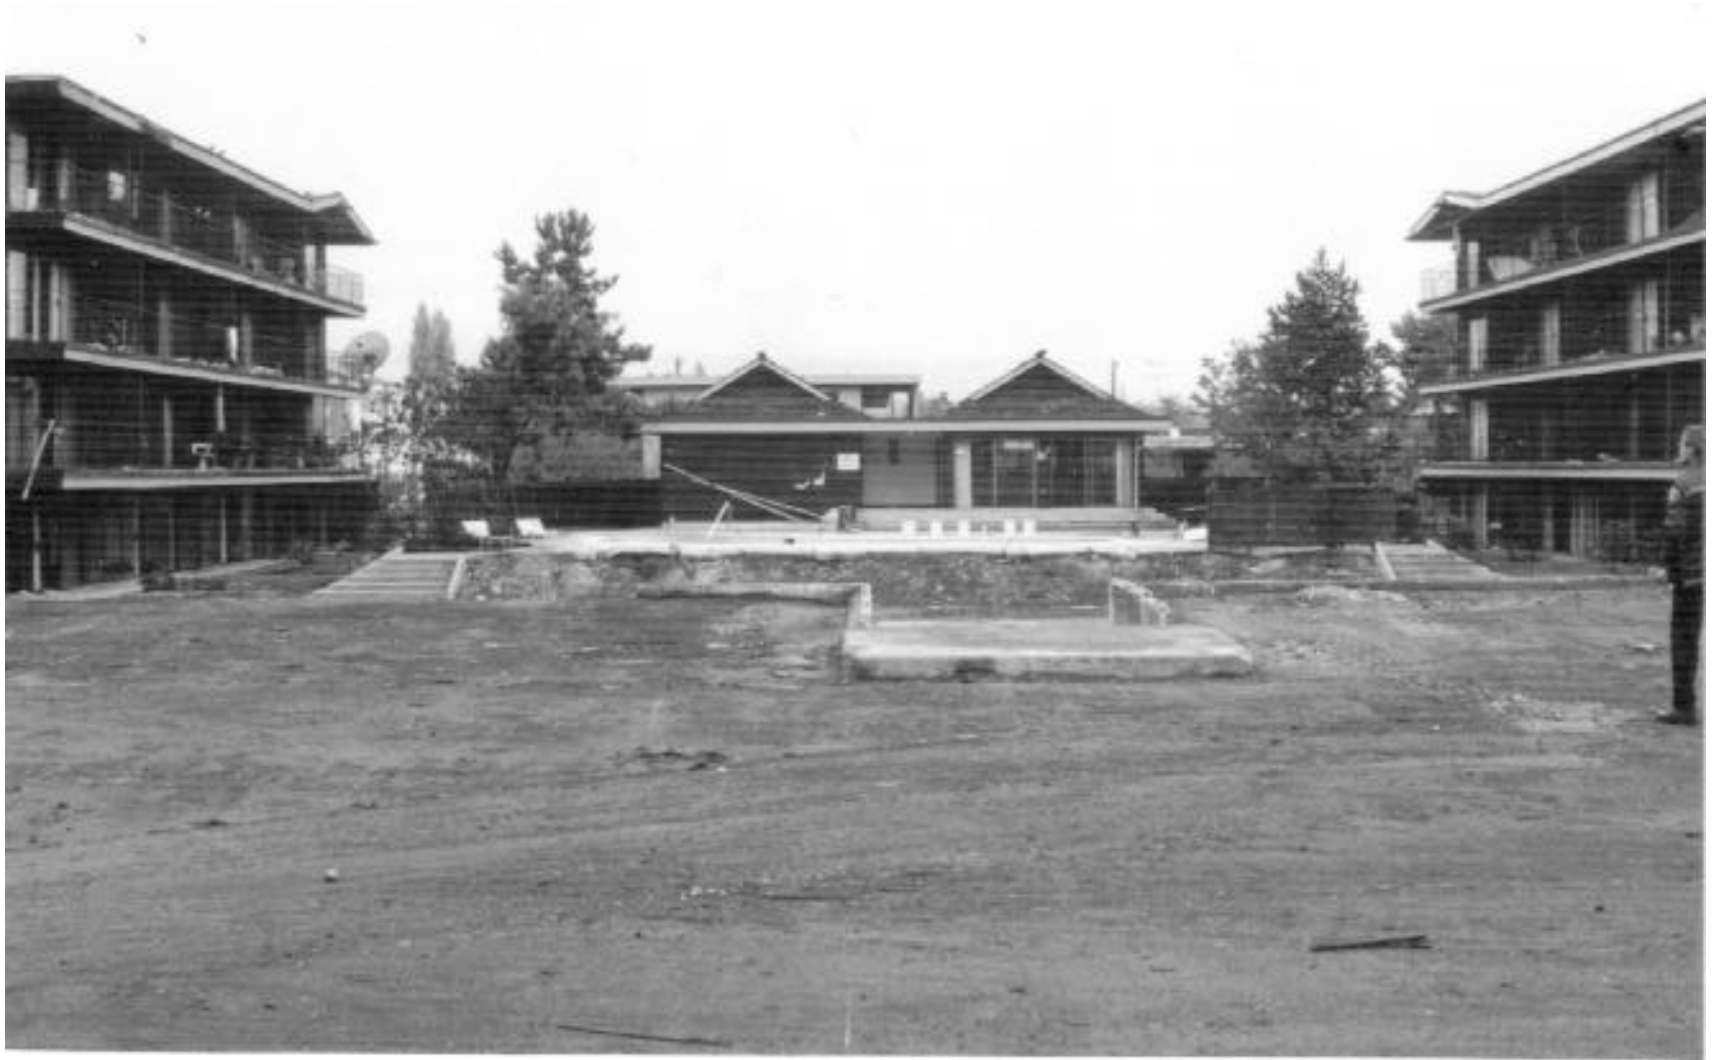
View of complex from south. Building A is on left, Building E on right. The small central building was a pool clubhouse. Buildings B, C and D were demolished and occupied the front (now vacant) space in the bottom third of the photograph.
